Ensure TD Aligned with WC

Model: All	Mar. 4, 2019
Serial #: All	
Alert

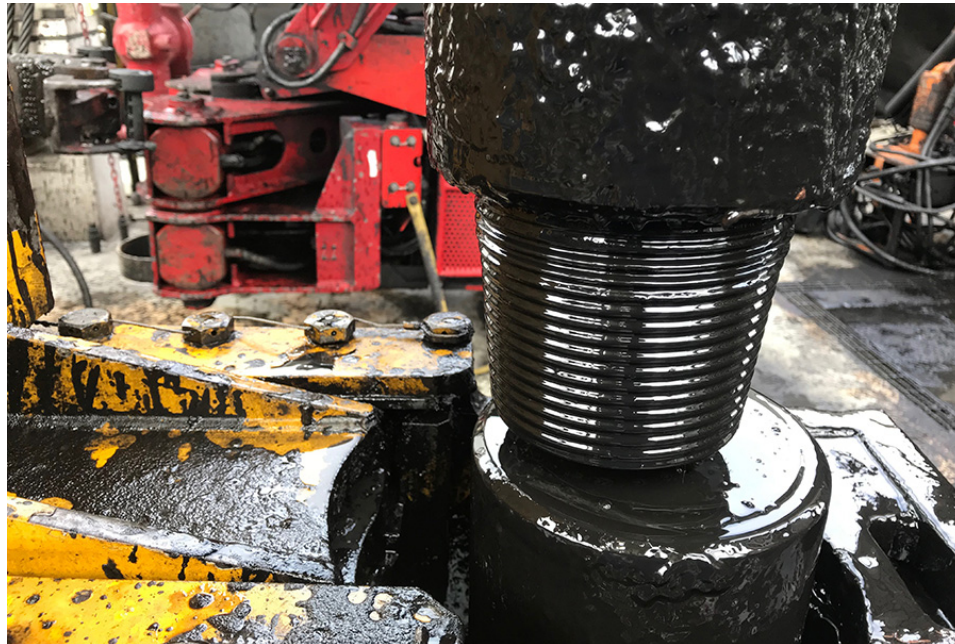
The alignment of the top drive with well center can affect the service life of the rotating components. A misaligned top drive will place additional side loads on the quill, lower well control valves, subs, and drill pipe connections. This will result in unscheduled downtime when these components fail due to fatigue.

Figure 1: Quill not Aligned with Well Center

Ensure that the top drive is properly aligned with well center to avoid excessive wear and fatigue on rotating components.

1. With the top drive at the drill floor and a drill pipe in the slips:
 - a. Use a level to verify the quill is vertical within 1 degree, and
 - b. Measure the end of the quill (or saver sub) to verify that the centerline of the top drive quill is within 1/2 inch of the centerline of the stump.
2. As needed, adjust the top drive horizontal position and angular alignment. Refer to the Canrig product manuals or the Tesco Installation Guide for the proper method.

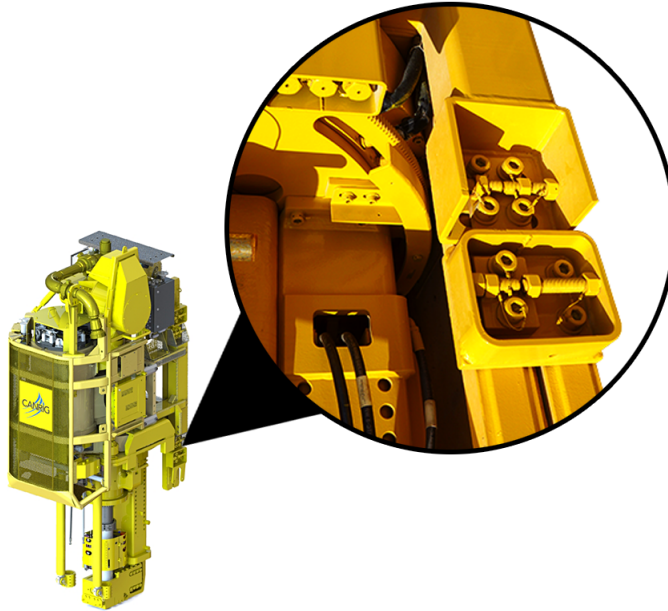
Figure 2: Adjustment Bolts on Guide Runner Assembly for Canrig 1250 Models
